Manhole Inspection Summary

Manhole # S150__041MH

Location Address: **2800 frederick av**

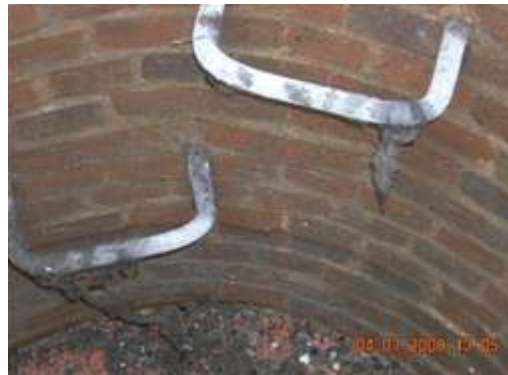
Defect 2

bench debris

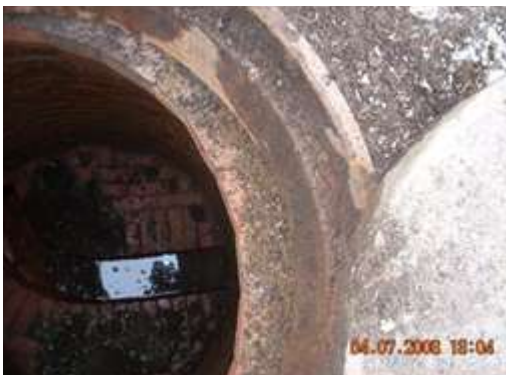
Defect 1

Surcharge ☒ **Evidence Of Surcharge** Depth: **3** (ft.) ☐ Active Surcharge Present

surcharge evidence

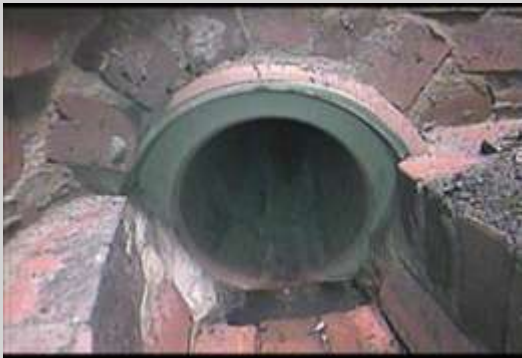
12 O'Clock Outflow

Pipe Height: **8.4** (in.) Rod and Bar (Angled)
Pipe Material: **Clay** ☐ Pipe Lined
Invert Depth: **7.59** (ft.) Flow Characteristics: **Slow**
Deposits: ☒ None ☐ Mud ☐ Sludge ☐ Debris ☐ Grease
Silt Depth: **0** (in.) Deposits Extent:
Infiltration: **None** Pipe Seal Cond: **Sound**

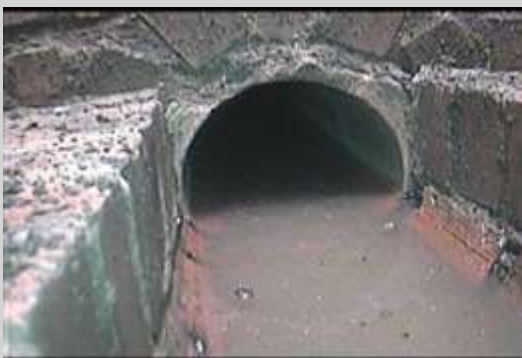
4 O'Clock Inflow

Pipe Height: **7.2** (in.) Rod and Bar (Angled)
Pipe Material: **Clay** ☐ Pipe Lined
Invert Depth: **7.75** (ft.) Flow Characteristics: **None**
Deposits: ☒ None ☐ Mud ☐ Sludge ☐ Debris ☐ Grease
Silt Depth: **0** (in.) Deposits Extent:
Infiltration: **None** Pipe Seal Cond: **Sound**
